Mr. Joe Bissell
Vice President of Administrative Services
**MONTEREY PENINSULA COMMUNITY
COLLEGE DISTRICT**
980 Fremont Street
Monterey, CA 93940-4799

RE: SWACC PROPERTY & LIABILITY INSPECTION FOLLOW UP AUDIT

Based upon the follow-up inspection conducted on November 20, 2008, please be advised of the following concerns or observations:

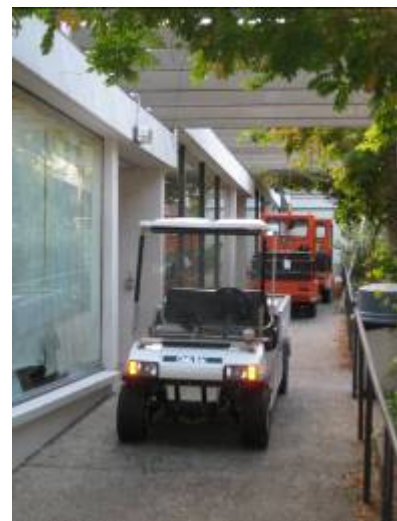
1. **College Central:** Utility Carts were parked along the rear entrance of College Central and down along the walkway overlooking the ravine. In case of an emergency or building evacuation, the utility carts would be considered a barrier and hamper safe egress from the building. All utility carts shall be parked so as not to obstruct normal egress from buildings or block exits, handicapped ramps or paths of pedestrian travel on sidewalks. Whenever possible utility carts shall be parked in the loading dock service area of a building.

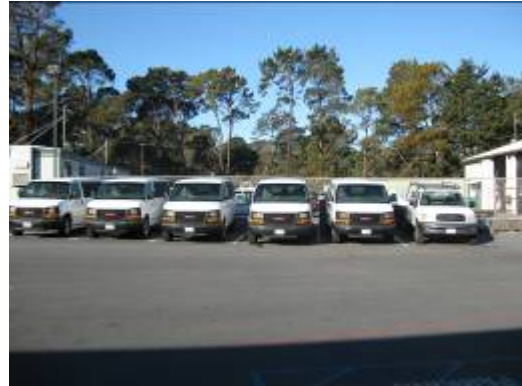
2. **Motor Fleet Parking – 9 and 12-Passenger Vans:** It was noted by the inspector that numerous College district vans were parked within the transportation yard of Maintenance & Operations. It was stated that all ground transportation for the College is arranged through the physical plant transportation department.

Ensure that departments and/or individuals that drive for or on behalf of the College, regardless of vehicle ownership, must be a Monterey Peninsula College authorized driver. And that all drivers should complete an on-line or live-person defensive driving course and/or van safety training as specified by the College.

- a) Only be permitted to drive vans if they have satisfied all insurability, van safety training, and requirements of other applicable College policies.
- b) Be responsible for ensuring that no more than nine (9) people, including the driver, travel in any van.
- c) Be at least 21 years of age.
- d) Posses a current valid California drivers license.
- e) Ensure that all persons, driver and passengers, wear seat belts at all times while the van is in motion.

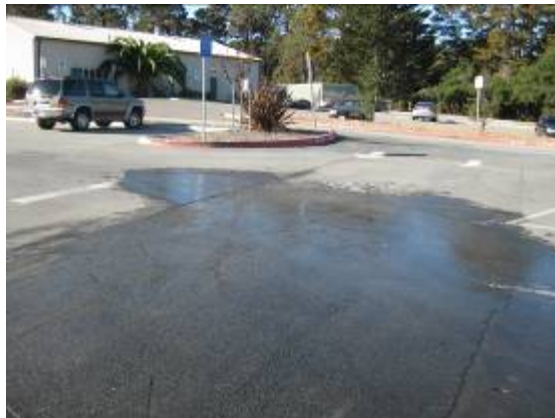
3. **Water Intrusion:** It was noted by the inspector that two (2) areas had undetermined water up-swell or long-term standing water. The areas in question were noted by the inspection party and Facilities was notified.

Water up-swell in Parking Lot C.

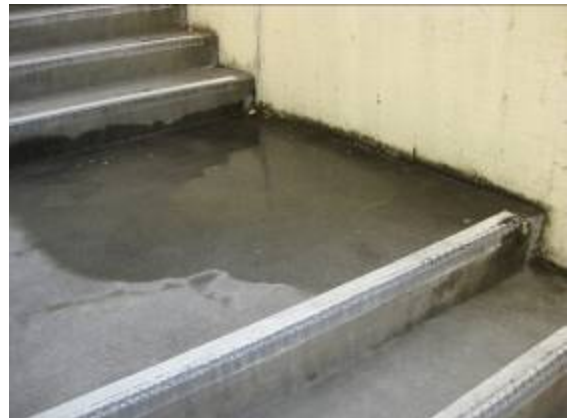
Standing water (w/algae) on stair landing of south-side of Physical Science Building

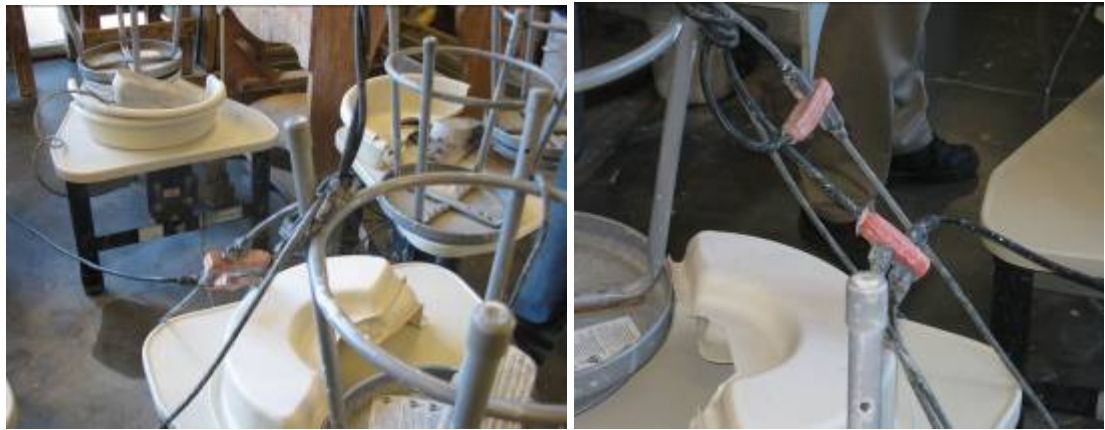
4. **Ceramic Department:** The supply of readily available electrical outlets is inadequate in some buildings, especially older ones. To meet power supply needs, extension cords or surge protected power strips are often interconnected, or “daisy chained,” to readily provide more outlets and/or to reach greater distances. Another common solution is to create a “mixed daisy chain,” interconnecting extension cords and power strips. However, interconnecting these devices is a violation of Occupational Safety and Health Administration (OSHA) regulations and the National Electrical Code because doing so can cause them to become overloaded, leading to their failure and a possible fire.

Several safe solutions exist. In many cases, a power strip energized by an extension cord or another power strip can simply be replaced by a power strip with a power cord of adequate length to reach an outlet. Only power strips equipped with internal fuses are acceptable as permanent wiring. Those lacking these fuses are equivalent to extension cords, and therefore may not be used as permanent wiring. When a power strip is installed, care must be taken to ensure that it is not suspended in mid-air by its power cord or cords plugged into it, resulting in excessive stress on electrical connections.

When there are not enough outlets to supply occupants’ needs, one solution is to request the installation of additional outlets. Their placement should avoid any need to run any wires across walkways, where they can create tripping hazards

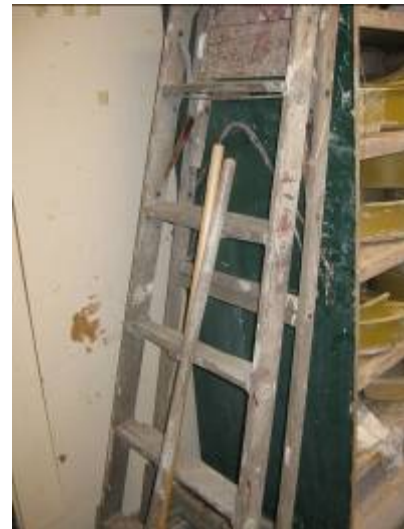
5. **Ceramic Department:** A worn wooden ladder was noted by the inspectors during the walkthrough of the Department. All wooden ladders should be free of splits, cracks, chips and all but small, tight knots. No ladder should have loose rungs or steps.

- A wooden ladder used outdoors should be shellacked, varnished or given two coats of linseed oil as a protective coating. Some new ladders may already have protective coatings; this will vary with the manufacturer.
6. **Theater Scene Shop:** Effective housekeeping can eliminate some workplace hazards and help get a job done safely and properly. Poor housekeeping can frequently contribute to accidents by hiding hazards that cause injuries. If the sight of paper, debris, clutter and spills is accepted as normal, then other more serious health and safety hazards may be taken for granted.

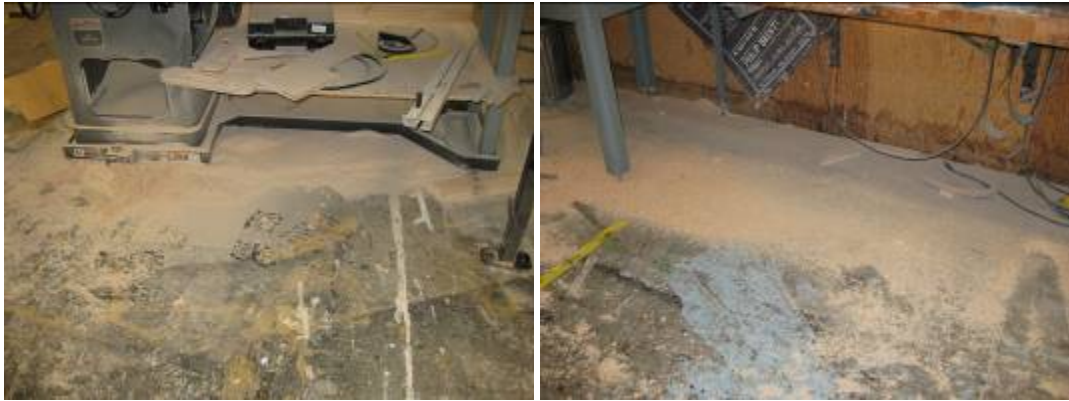
Accumulated sawdust from mill operation.

Housekeeping is not just cleanliness. It includes keeping work areas neat and orderly; maintaining halls and floors free of slip and trip hazards; and removing of waste materials (e.g., paper, cardboard) and other fire hazards from work areas. It also requires paying attention to important details such as the layout of the entire workplace, aisle marking, the adequacy of storage facilities, and maintenance. Good housekeeping is also a basic part of accident and fire prevention.

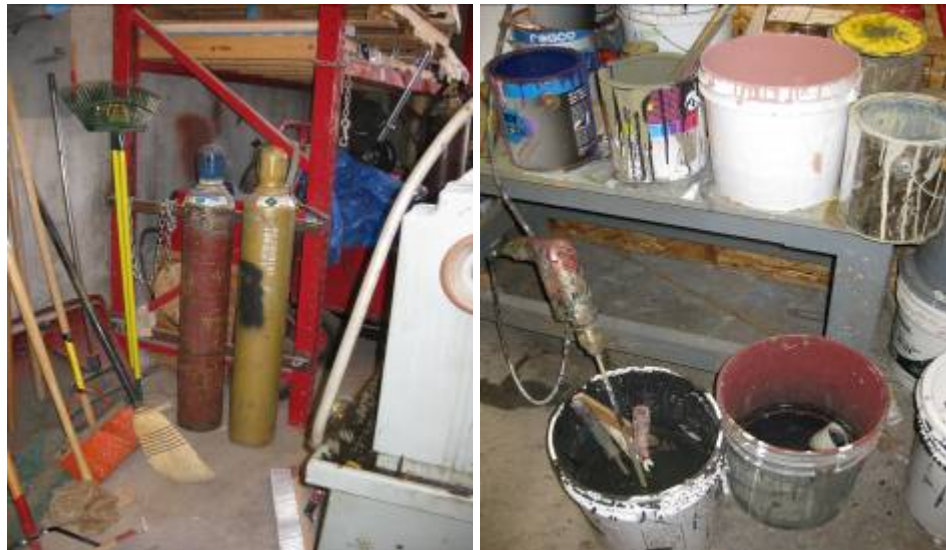
Unchained compressed gas cylinders.

Open containers of paint and paint washout (waste).

Effective housekeeping is an ongoing operation: it is not a hit-and-miss cleanup done occasionally. Periodic "panic" cleanups are costly and ineffective in reducing accidents.

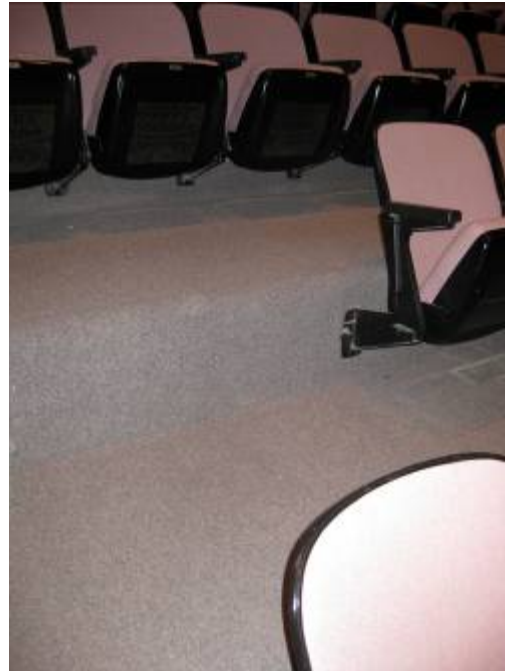
- 7. Performing Arts Building - Theater Seating:** It was noted that there is only one (1) ADA wheelchair space for the 350+ seat theater. And the entrance to this space is through the side door leading up from the rear of the theater (scene shop entrance). There is no wheelchair access to a restroom from this location.

There is also no stair lighting at this location. Patrons leaving during the performance may trip and fall from the aisle above. It is recommended that glow tape or other device be put down to highlight this step down/up.

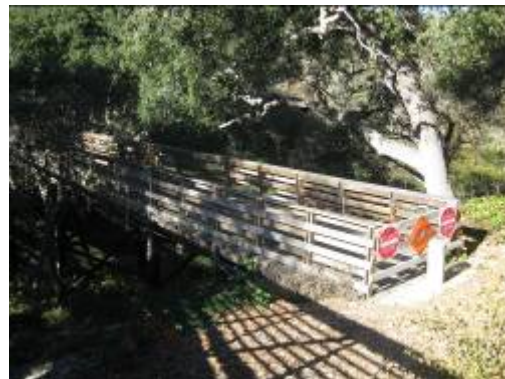
- 8. Lecture Forum Bridge:** A new pedestrian bridge replaces an existing bridge that connected the west and east sides of campus at the Lecture Forum. The new bridge is accessible to the disabled and was designed to be more visible and provide a clearer path for pedestrians. The bridge also serves to carry utilities across the ravine. Installation of the new pedestrian bridge was completed in July 2008.

The old bridge has been closed and warning signs posted at either end of the structure. Demolition is slated once all utility lines have been re-routed.

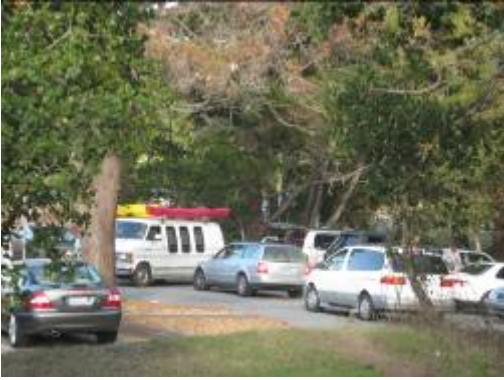
12. **Monterey Farmers Market Parking:** The placement of the market inadvertently creates a “dead-end” in one section of the Parking Lot A. The inspector noted numerous automobiles driving down along this lane to “park close” to the event. When no stalls were open, vehicles had difficulty backing up or stopped altogether waiting for an open

stall, blocking other vehicles from leaving. This parking arrangement lends itself to potential “fender-benders” and pedestrian mishaps.

It may be prudent to block access of this section of parking stalls with traffic cones or other barriers.

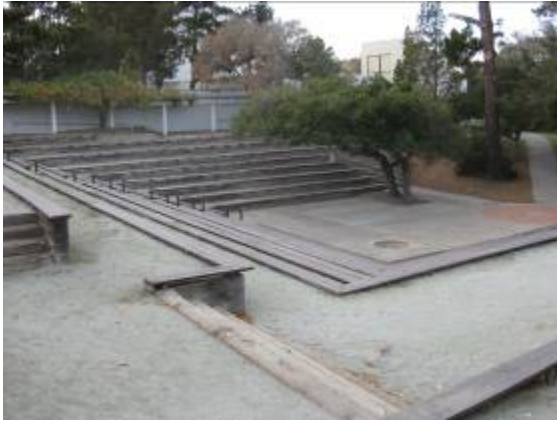
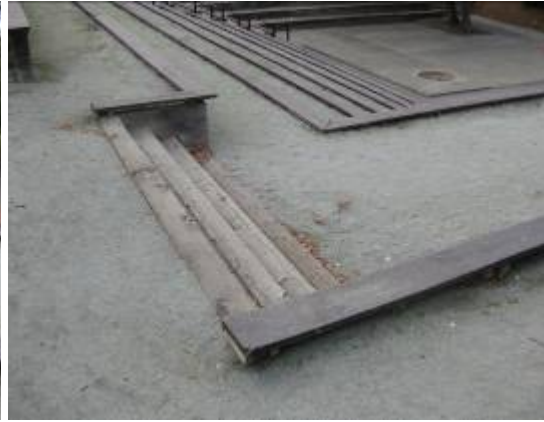
- 13. Amphitheatre Seating:** The landscape timber used as sitting and steps should receive special inspection and maintenance for splinters, rough edges, sharp corners, and loose or protruding nuts, bolts, etc. There were areas within this structure that showed severe deterioration and splintering.

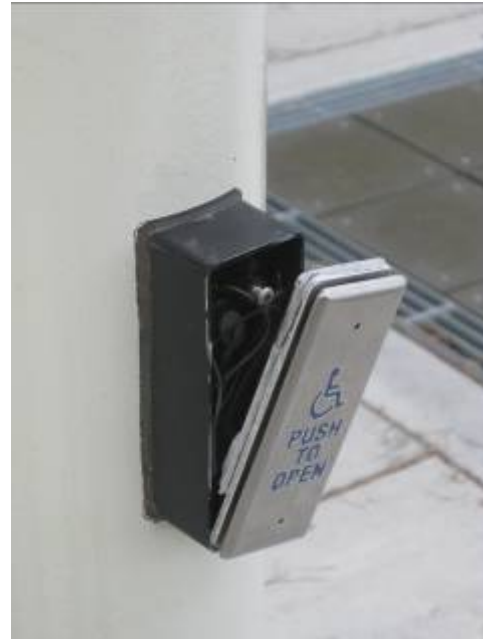
- 14. ADA Door Activator Push Plate:** Directly outside of the Child Development Center. The plate cover was askew and the internal wiring was exposed to the elements.

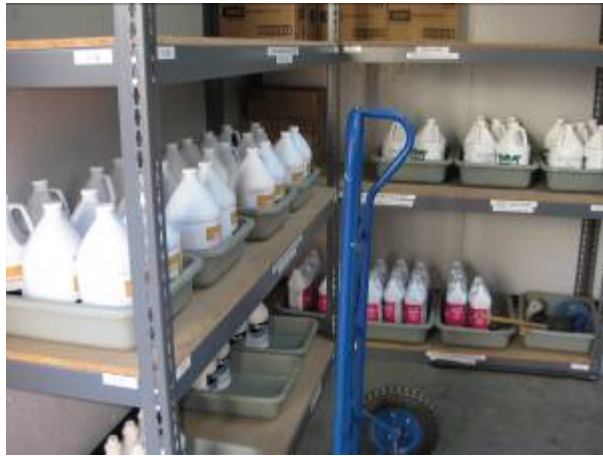
Custodial Warehouse

Secondary Containment: In those areas that have liquid chemical or product storage, the inspectors noted the use of secondary containment. Secondary containment means that when a chemical spill develops the spill will be contained and controlled in a secondary area (i.e., specially designed safety storage cabinet) which will reduce the risk of chemical exposure, fire, explosion, etc. Several regulatory agencies have stated that "secondary containment" must be provided and that spill control procedures be adopted for hazardous chemicals. The best practice examples below illustrate the use of secondary containment.

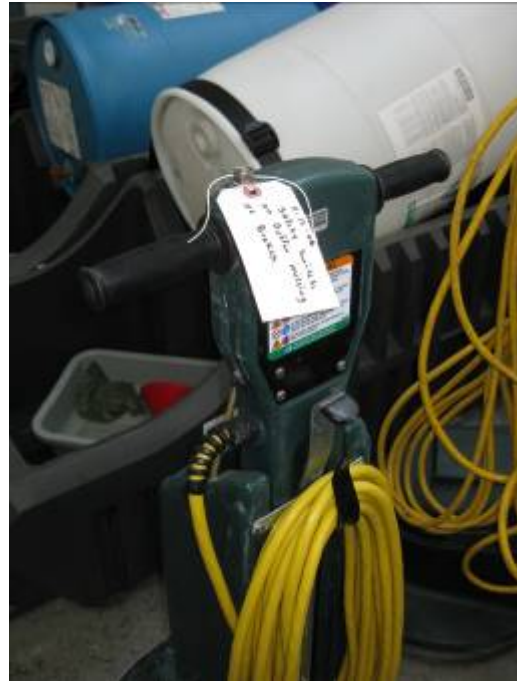
Damaged or Malfunctioning Equipment Notification: It was noted by the inspectors that numerous electrical equipment not operating properly were taken out of service and tagged as “Do Not Use” and the reason for the needed repair. This best practice highlights the reporting procedures and notification requirements of an active safety program.

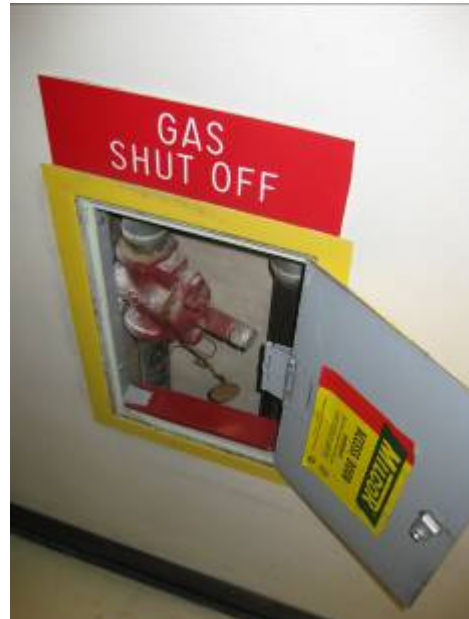
Labeled Utility Shut-Off Signage: As per Fire and Life Safety Codes, all of the emergency shut-off locations for electrical, gas, and water were noted and labeled. All of the necessary wrenches and hardware were present and available for use.
