Mr. Joe Bissell
Vice President of Administrative Services
**MONTEREY PENINSULA COMMUNITY
COLLEGE DISTRICT**
980 Fremont Street
Monterey, CA 93940-4799

RE: SWACC PROPERTY & LIABILITY INSPECTION FOLLOW UP AUDIT

Based upon the follow-up inspection conducted on November 20, 2008, please be advised of the following concerns or observations:

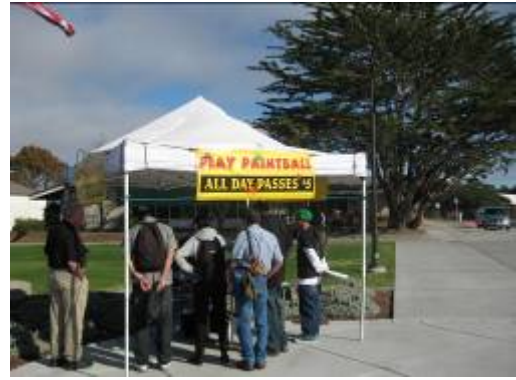
9. Outside individuals, vendors, and organizations are able to use College property to promote community activities and businesses. Ensure that all events and activities have the prior approval of the designated College authority before they will be permitted to occur on College property.

All user groups and/or individuals shall be required to provide the District with a hold harmless and indemnification agreement acknowledging that they will be financially responsible for any losses, damages or injuries incurred by any person as a result of their use of the facilities.

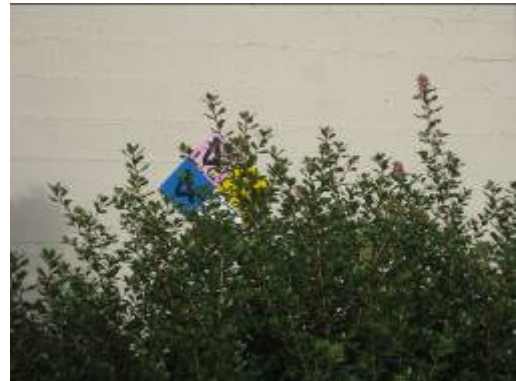
10. Ensure that all signage and placards are visible and properly displayed for emergency responders.

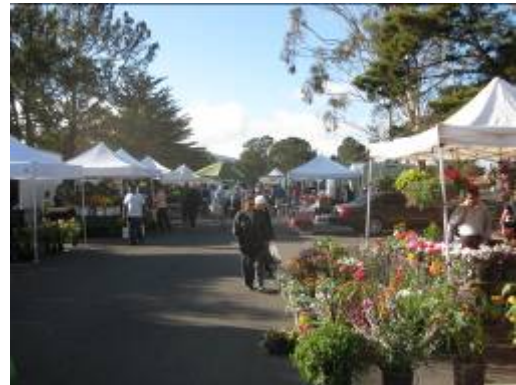
11. **Monterey Farmers Market** – Hosted year-around on the campus every Thursday between the hours of 2:30 and 6:00 p.m. The Market has a variety of produce vendors, flowers and plants from the local nurseries, and specialty items from merchants.

Freshly-caught fish were displayed on ice or were pre-packaged and chilled. Shell stock clams, mussels, and oysters were displayed outside in shallow trays of sea water.

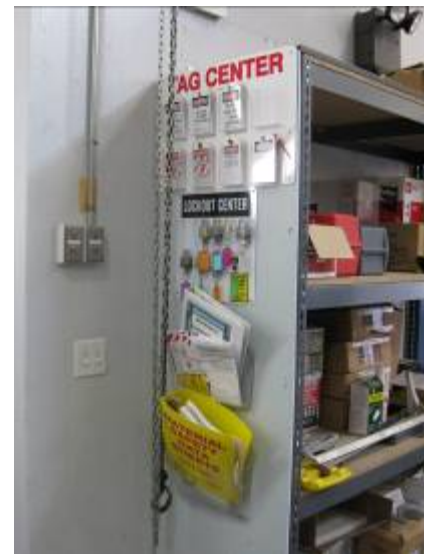
The Facilities Department has implemented a lockout/tagout program. Employees have had training in understanding the significance of implementing the procedures. Throughout the Maintenance & Operations Department, the inspectors noted Material Safety Data Sheet (MSDS) binders and Right-to-Know stations
